Actual Measured & Verified Savings Exceeded Projections

Fort Riley

<i>Industry:</i>	U.S. Army
<i>Locations:</i>	Fort Riley, KS
<i>Facility Type:</i>	Assorted
<i>Project Type:</i>	HVAC Renovation
<i>Duration</i>	12 months
<i>Energy Savings</i>	\$147k/year
<i>Other Savings</i>	\$99k/year
<i>Simple Payback</i>	3.38 years
<i>Project Value</i>	\$900,000
<i>ESCO Client:</i>	Southland Energy

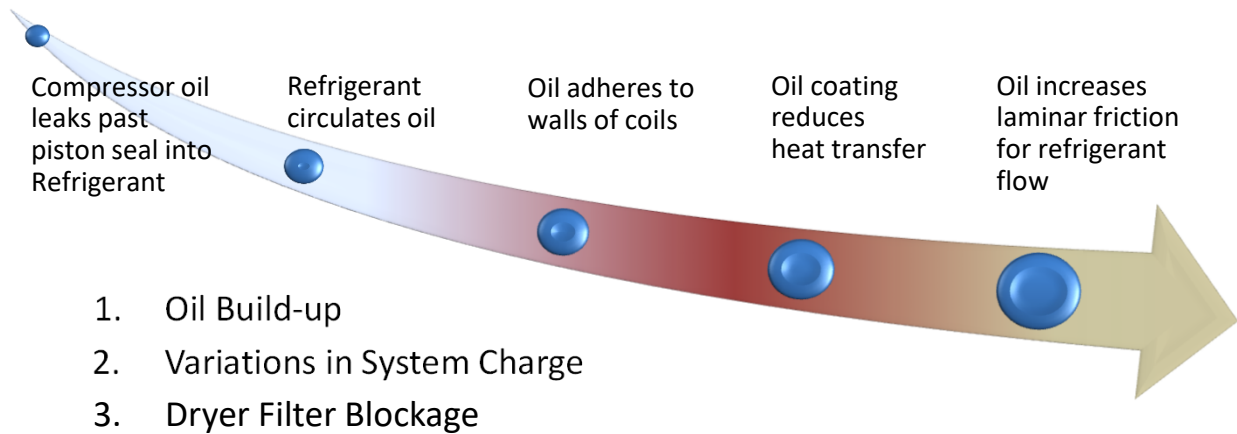
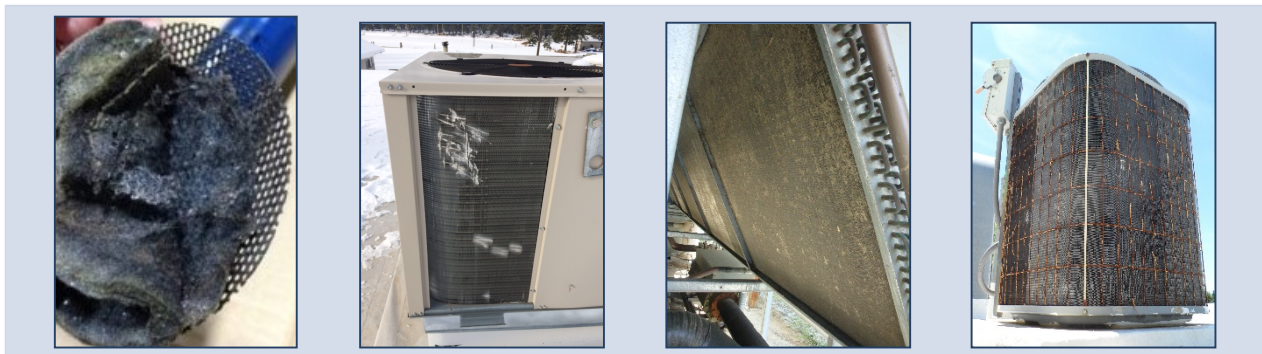
Three Types of Refrigerant System Deterioration:
